SPOONWOOD POND DAM

NH 00338

PHASE I INSPECTION REPORT  
NATIONAL DAM INSPECTION PROGRAM

AUGUST 1978

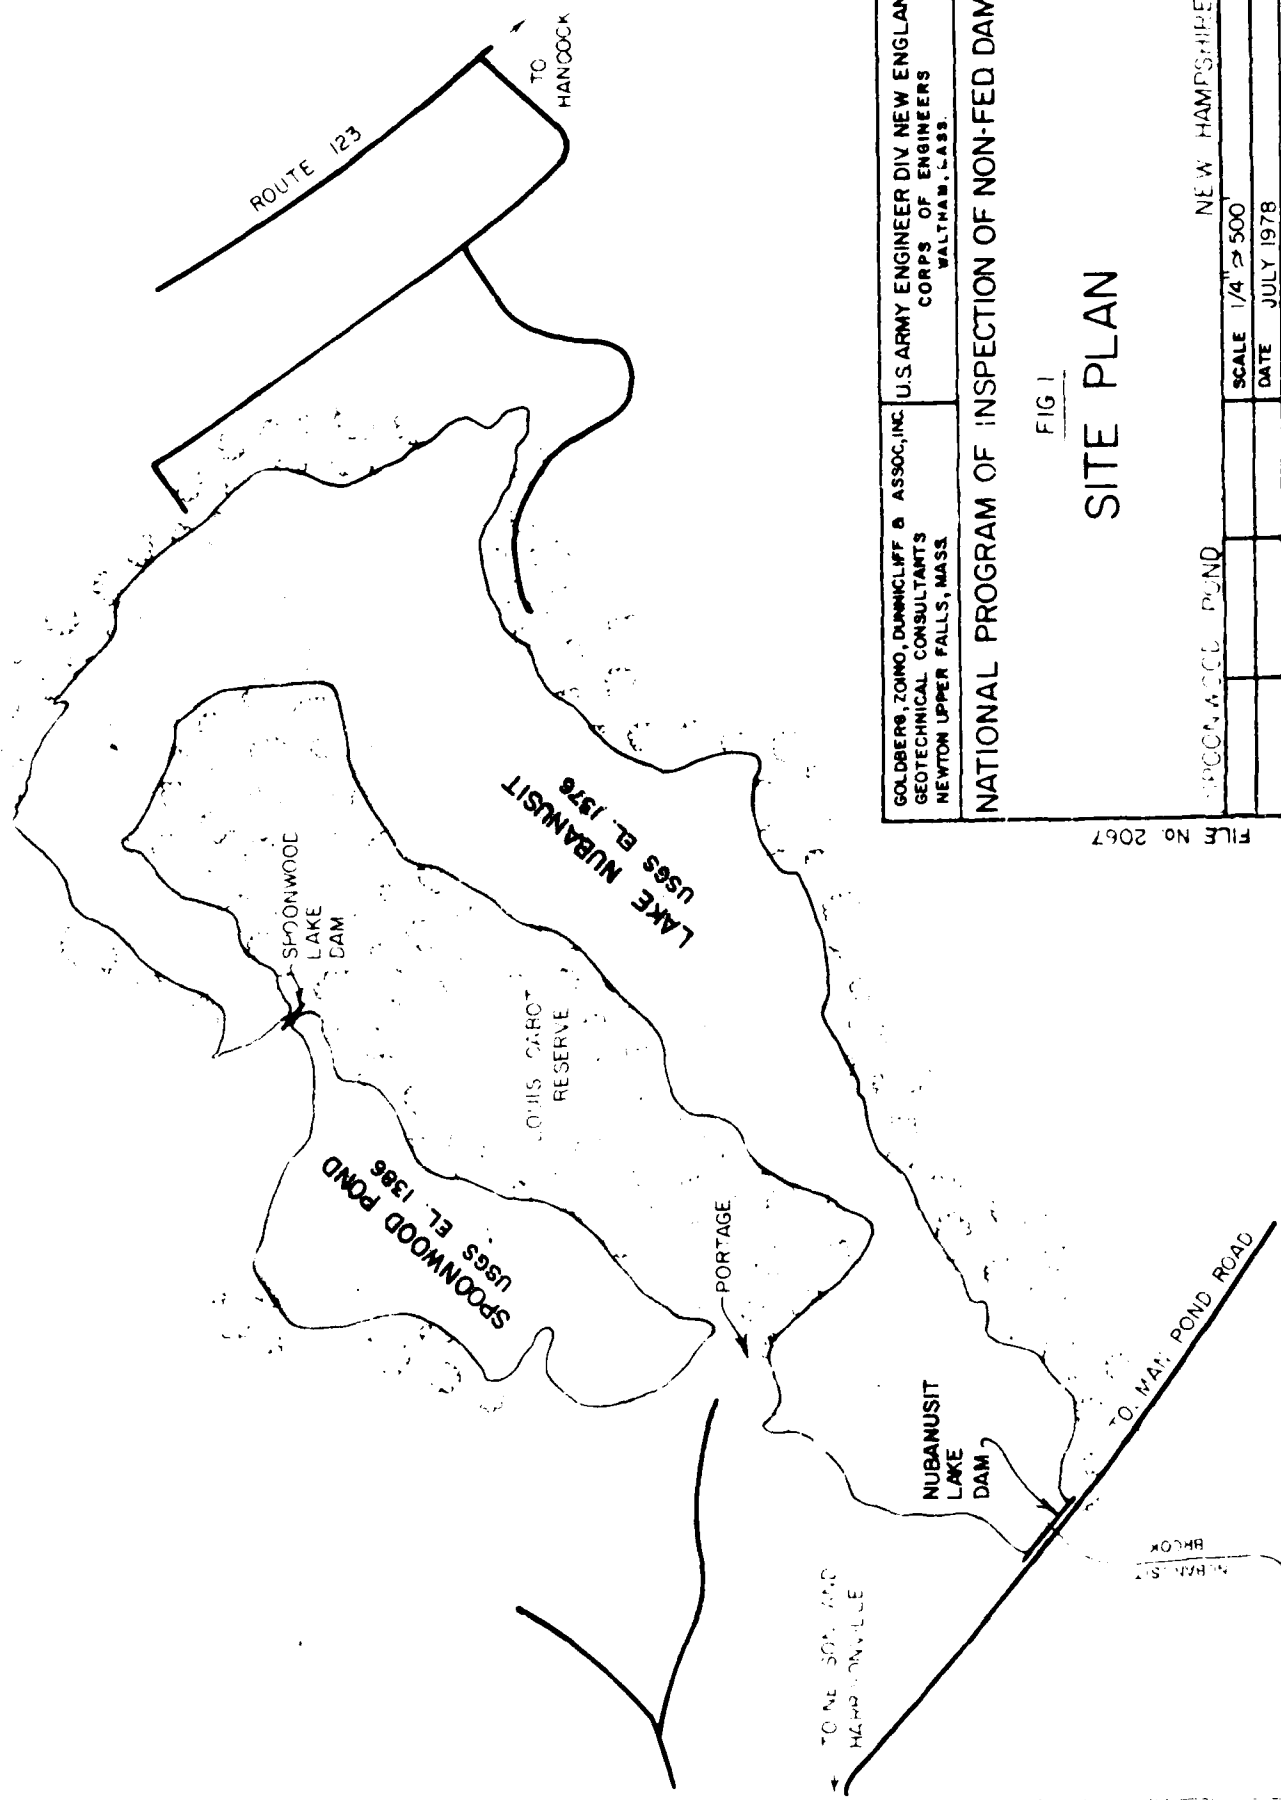
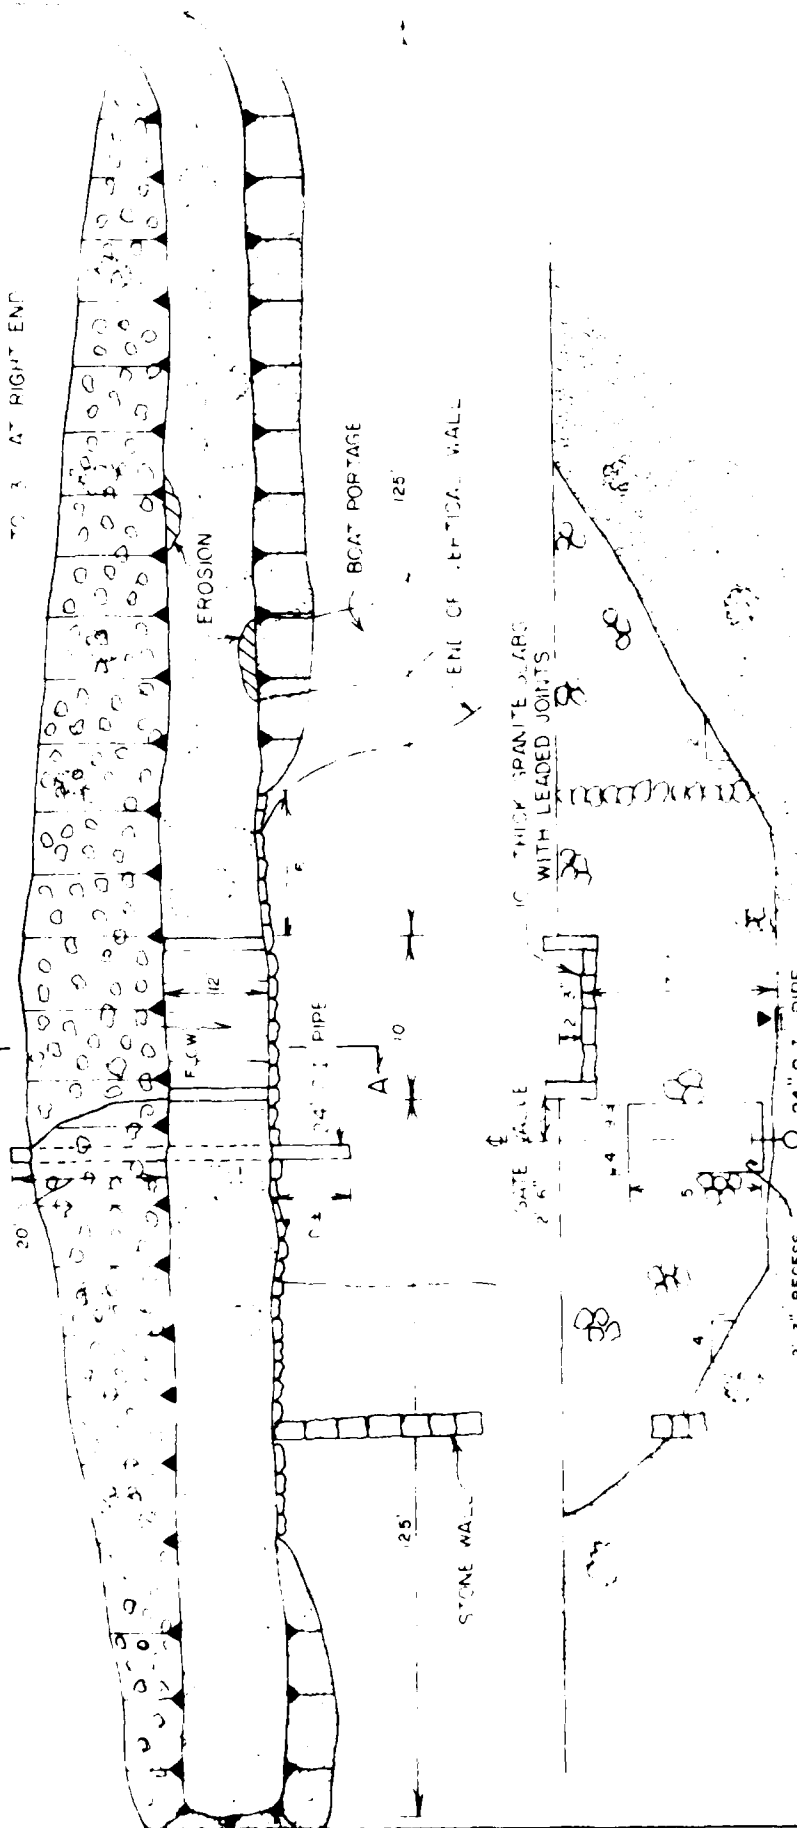
FIG. 2

The dam consists of a 280 foot long earth embankment with a maximum height of approximately 12 feet (Figs. 2 and 3). The embankment includes a 10 foot long spillway constructed of granite slabs and a 24-inch diameter cast iron pipe with gate valve (Fig. 3). The downstream side of the dam near the spillway and cast iron pipe consists of a vertical wall of natural, unmortared stone. The dam has some riprap on both the upstream and downstream slopes.
